Amber[®]

Troubleshooting Guide

Amber[®] LiSi-POZ Troubleshooting Guide

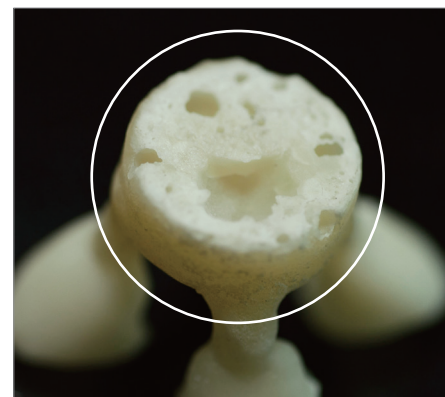
Case 1 Porous after pressing

Porous occurred on the ingot after pressing.

When ingot is pressed at a higher temperature than the recommended temperature, the surface boils and causes porosity.

- Press to fit the recommended temperature on the pressing schedule table.
- If recommended temperature schedule has been applied, check the calibration of the pressing furnace. If calibration is difficult, decrease the pressing temperature by 10°C lower than the recommended temperature.
- Shorten the holding time.
- Pressing at an overheated temperature may result in porous and thick reaction layers on the ingot surface.

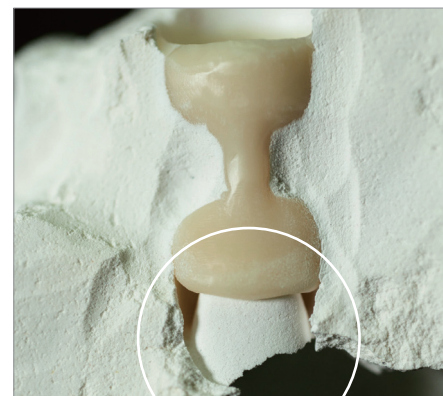
Case 2 Insufficient pressing not as much as wax pattern

Ingot has not been melted enough into the margin part.

- This problem happens when ingot has not been crystallized well at the optimal temperature.
- Pressing temperature is low.

- Press to fit the recommended temperature schedule table. (Please refer to the Amber® Pressing, Amber® LiSi-POZ Pressing Schedule)
- If recommended temperature schedule has been applied, check the calibration of the pressing furnace. If calibration is difficult, increase the pressing temperature by 10°C higher than the recommended temperature.
- Make sure there is sufficient hardening of the investment material so that it does not crack during working. Do not apply any impacts or shocking. The ingot may not be pressed properly when the investment material is cracked.

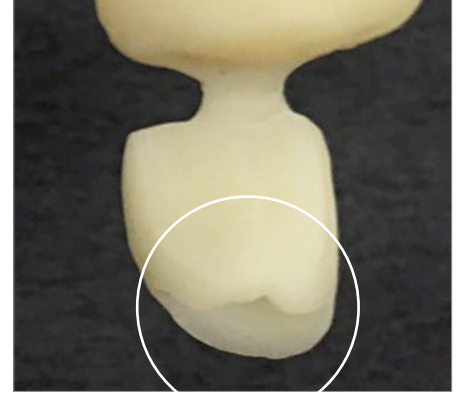
Case 3 Insufficient pressing not long enough to the margin part

Ingot was not pressed long enough to the margin part.

- 1) The residual gas may exist inside due to insufficient holding time for wax burnout.
- 2) The sprue may be fixed in an inappropriate way while setting the wax sprue.

- Take sufficient holding time in burnout process. At least one hour is recommended. Or residual gas may interfere with appropriate processing.
- Follow the time table recommended by investment material manufacturer.
- Observe below guidelines when you work on wax sprue.
- When press body is large, add air vent to reduce internal pressure generated by pressing.
- In case of applying more than two press bodies and/or when there is height gap between press bodies, add sprue between the bodies.

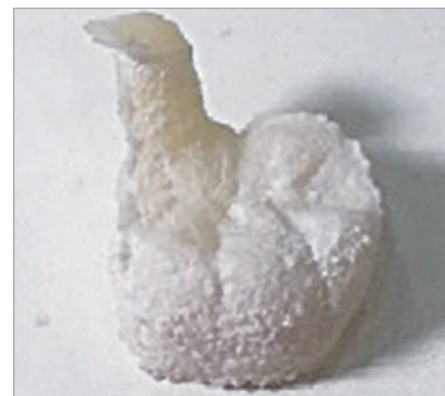
Case 4 Too many reaction layers

Too many reaction layers remain roughly on the surface after divesting.

- 1) Due to overheating pressing temperature or overlong holding time.
- 2) The residual gas may exist inside due to insufficient wax burnout.

- Press to fit the recommended temperature schedule table.
- If recommended temperature schedule has been applied, check the calibration of the pressing furnace.
If calibration is difficult, decrease the pressing temperature by 10°C lower than the recommended temperature.
- Do not use wetting agent.
- The reaction layers may be formed due to the residual gas inside, so please proceed with sufficient burnout holding time.
- Do not reuse any ingot.
- Observe the mixing ratio recommended by investment material manufacturer.
- Use the investment material which generates less reaction layers.

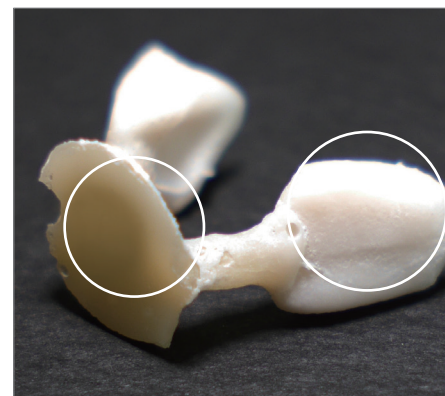
Case 5 Discoloration or two colors after pressing

Discoloration or two colors appears after pressing.

- 1) Due to the higher pressing temperature than the recommended temperature.
- 2) Due to reused ingot.

- Press to fit the recommended temperature schedule table.
- If recommended temperature schedule has been applied, check the calibration of the pressing furnace.
If calibration is difficult, decrease the pressing temperature by 10°C lower than the recommended temperature.
- Do not reuse any ingot. If reused, the results may come out in different colors from its original shade.

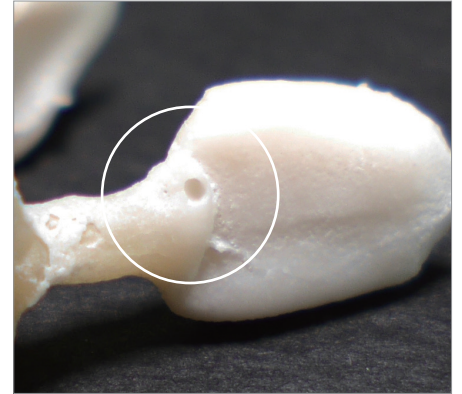
Case 6 Formation of bubble and excessive reaction layers

There is porous and excessive reaction layers on the surface after pressing.

Insufficient amount of ingot causes unstable pressing work and the consequent lack of pressure results in gas porosity.

- Check the weight of wax pattern as below to make sure the ingot weight is enough to press.
(R10 1ea up to 0.7g, R20 1ea up to 1.7g)
- Do not reuse any ingot.

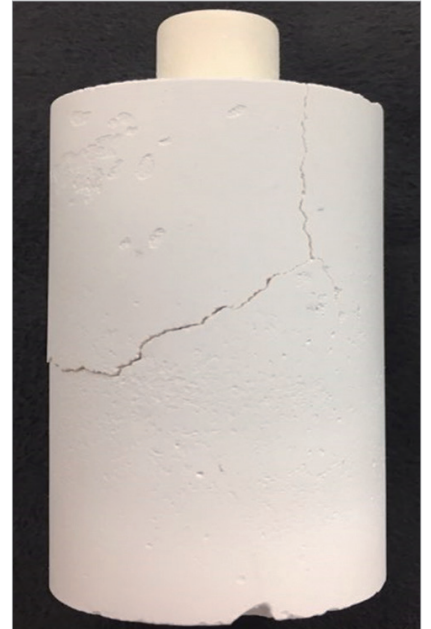
Case 7 Cracks of an investment ring during the pressing process

Investment ring cracks during the pressing process.

- 1) Residual investment material on the Alox plunger surface.
- 2) The ring base may not be horizontal when pressed.
- 3) Some impact may be applied to the surface of the investment material.
- 4) Incorrect mixing ratio of investment material.
- 5) Insufficient curing time of investment material.

- Get rid of residual investment materials clearly on the Alox plunger.
- Place the ring base surface horizontally to carry on the pressing.
- Be careful not to apply external impact to the ring.

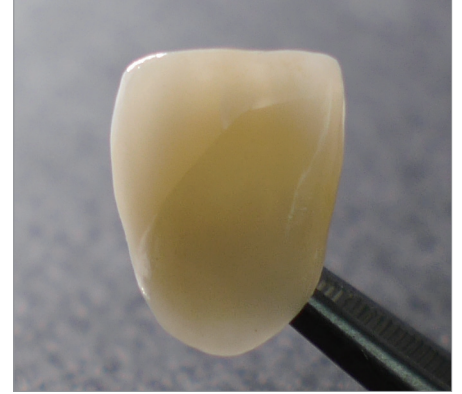
Case 1 Cracks after cut-back / layering technique

Cracks after cut-back/layering technique has been applied.

- 1) The guideline for minimum core thickness may not have been observed when building up powder.
- 2) Fractures due to thermal shock.
- 3) Compatibility issue with porcelain powders in use.
- 4) Degeneration of the core due to the repetition of excessive firing over 800°C

- Layer thickness between framework and veneering powder must be strictly observed.
- Minimize thermal shock to the glass ceramic products.

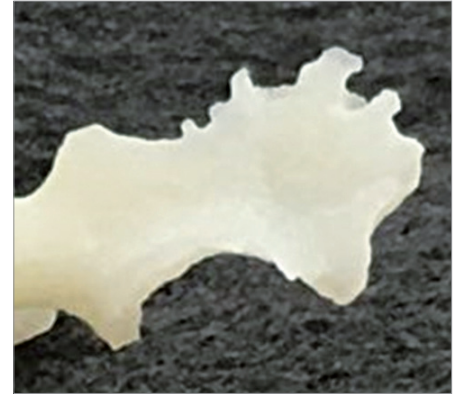
Case 2 Cracks on the margin part of the restorations

Cracks in the part of thin restorations after divesting

When alumina oxide is used in sand blasting.

- Glass bead with a particle size 25-50 micro is recommended to use for sand blasting.
- While the surface of the glass bead is round, alumina oxide particles are rough as the pictures below. Hence sand blasting with alumina oxide is not recommended for glass ceramic products.

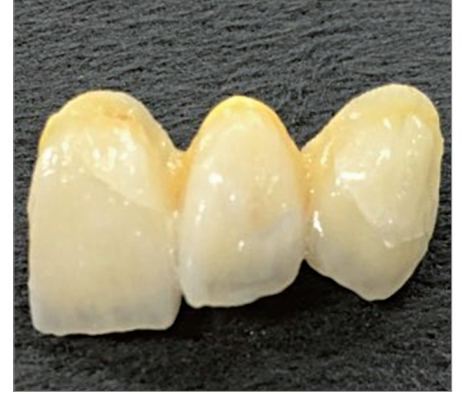
Case 3 Cracks during the the polishing process

Crack occurs during the polishing process.

- 1) When electroplated diamond burs were not used for polishing.
- 2) Thermal shock caused by improper, severe polishing.

- During the polishing process, be sure to use electroplated diamond burs for glass ceramics.
- Conduct your polishing job at a low working rate when you work with a hand piece to prevent the thermal shock. Spray water on the surface of the restorations continuously to keep the restoration wet.
- During the polishing process, make sure that recommended minimum thickness of the restorations is well maintained.
- Do not trim the connecting part of the framework severely.
