Amber[®]

Troubleshooting Guide

Amber[®] LiSi-POZ Troubleshooting Guide

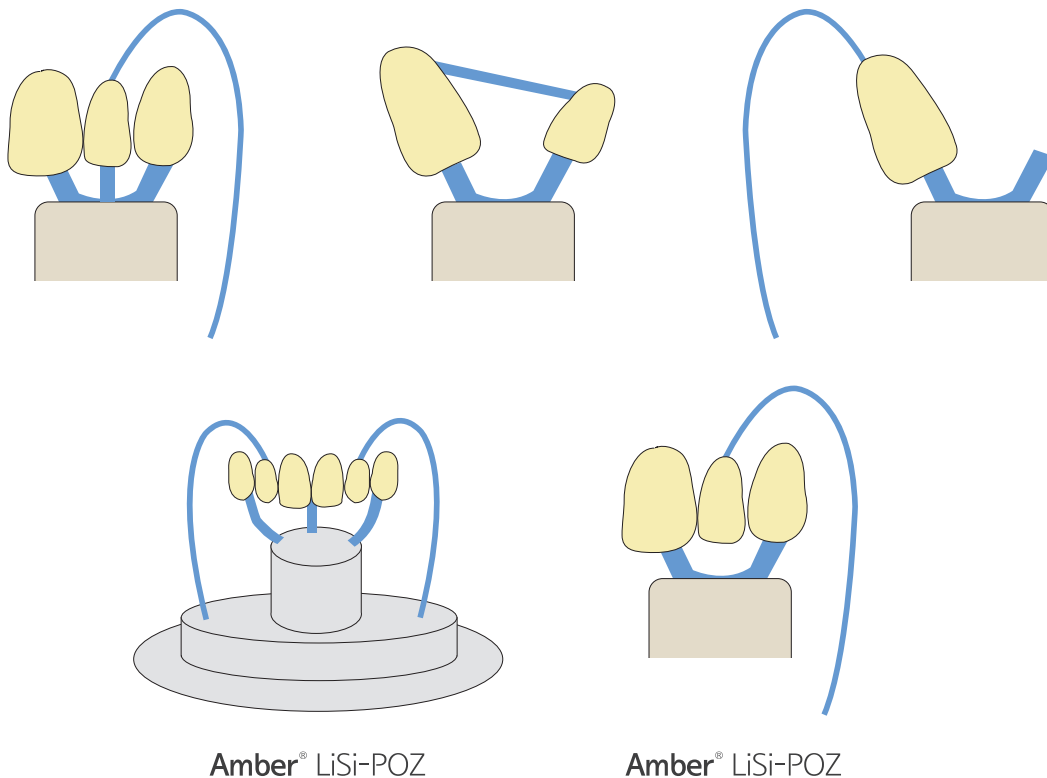
Cause

- 1) The residual gas may exist inside due to insufficient holding time for wax burnout.
- 2) The sprue may be fixed in an inappropriate way while setting the wax sprue.

- Take sufficient holding time in burnout process. At least one hour is recommended. Or residual gas may interfere with appropriate processing.
- Follow the time table recommended by investment material manufacturer.
- Observe below guidelines when you work on wax sprue.
- When press body is large, add air vent to reduce internal pressure generated by pressing.
- In case of applying more than two press bodies and/or when there is height gap between press bodies, add sprue between the bodies.

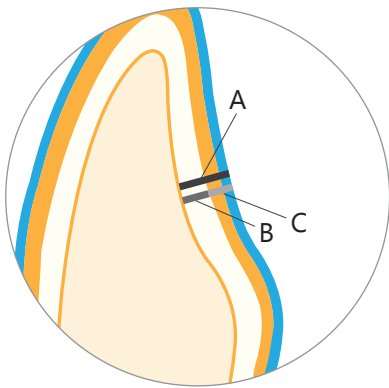
Cracks after cut-back/layering technique has been applied.

- 1) The guideline for minimum core thickness may not have been observed when building up powder.
- 2) Fractures due to thermal shock.
- 3) Compatibility issue with porcelain powders in use.
- 4) Degeneration of the core due to the repetition of excessive firing over 800°C

- Layer thickness between framework and veneering powder must be strictly observed.
- Minimize thermal shock to the glass ceramic products.

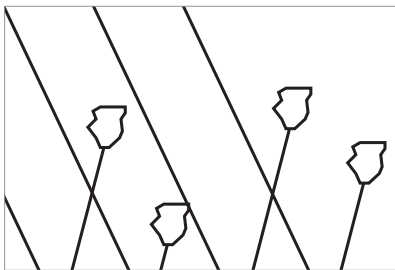
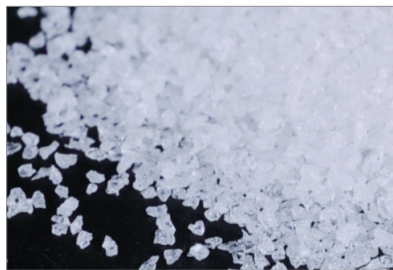
Alumina oxide

- Glass bead with a particle size 25-50 micro is recommended to use for sand blasting.
- While the surface of the glass bead is round, alumina oxide particles are rough as the pictures below. Hence sand blasting with alumina oxide is not recommended for glass ceramic products.
